OCS Report
MMS 88-0007

**Investigation of
November 10, 1986
Blowout and Fire
OCS Lease 0244
West Cameron Block 71**

**Gulf of Mexico
off the Louisiana Coast**

U.S. Department of the Interior
Minerals Management Service
Gulf of Mexico OCS Region

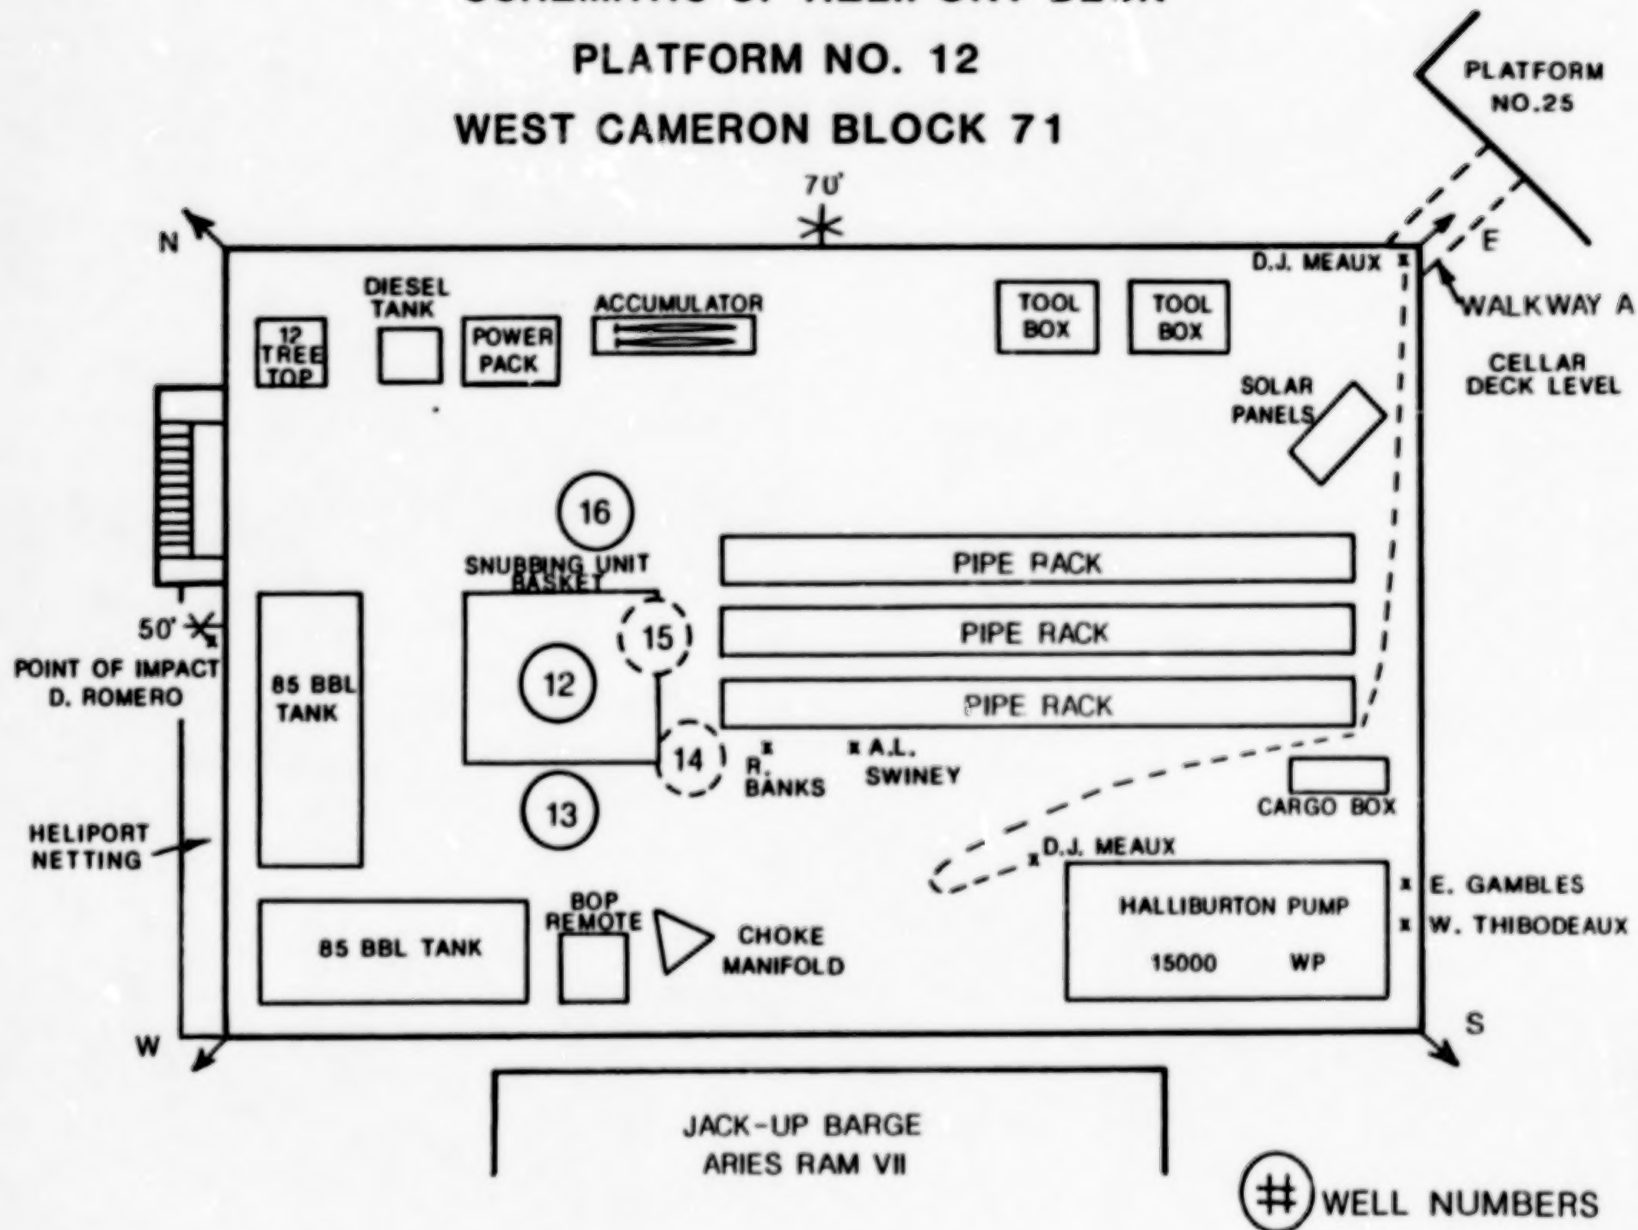
Attachment 4

The three Otis personnel located in the workbasket were blown out, two landing near a pipe rack on the heliport deck. (For schematic of heliport deck, see appendix, attachment 4.) The other Otis employee was blown out in the opposite direction, breaking through the wire netting surrounding the heliport deck before landing in the water. (For schematic of elevation of platform decks, see appendix, attachment 5.)

**SCHEMATIC OF HELIPORT DECK
PLATFORM NO. 12
WEST CAMERON BLOCK 71**
